**CONSERVATION AREA
CHARACTER APPRAISAL**

**HOSPITAL STREET,
TAMWORTH**

**TAMWORTH BOROUGH
COUNCIL**

Date: June 2007

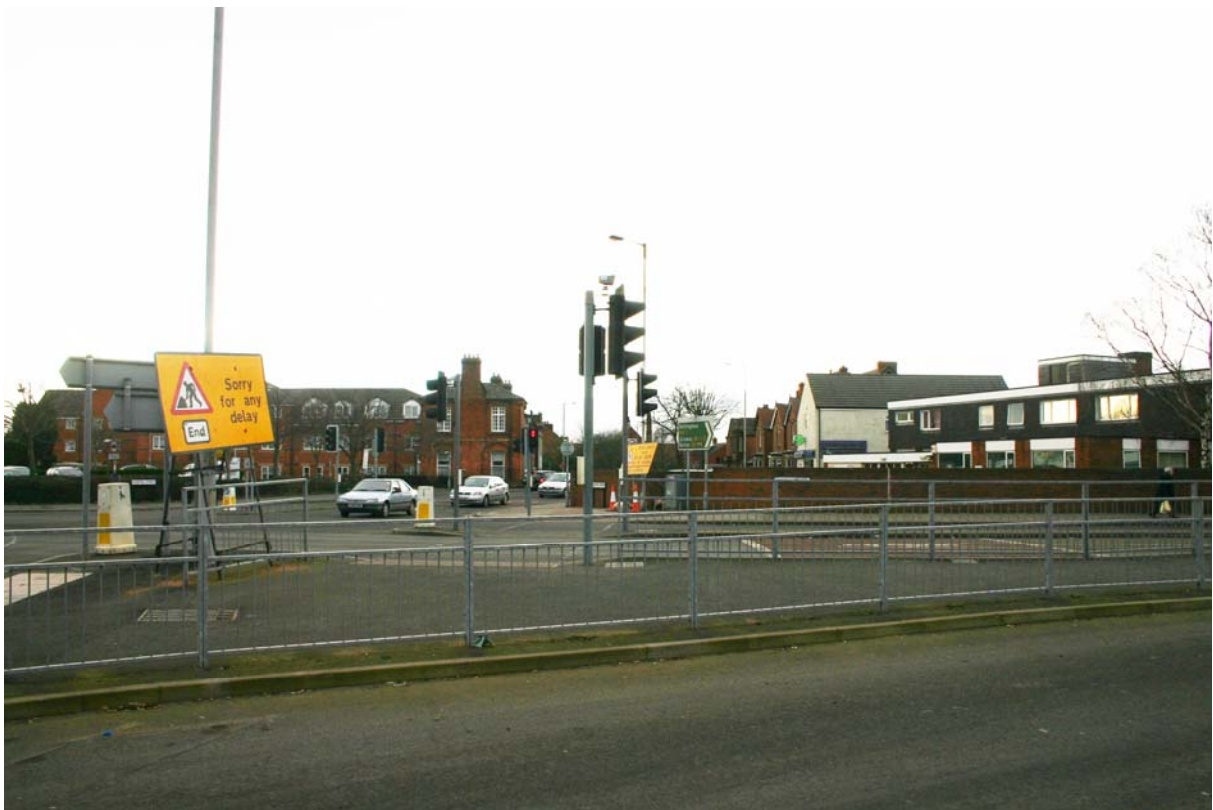
Looking west to Hospital Street, the cluttered major traffic intersection dominating the views

- 5.1.17 The chief negative feature of the area is its generally uninviting approach from the junction with Upper Gungate. The western side of the latter is included in the conservation area but its character has been altered to such an extent that it no longer enhances or preserves its character and appearance. The setting of the few surviving (but altered) late Victorian properties on the street frontage (Nos. 27-37) has been altered beyond recognition, with late 20th-century housing to the north (Oldbury Court), the 1970s health centre to the south, and a large modern garage and petrol station opposite, not to mention their position between two major traffic intersections on the main routes into Tamworth. The former residential and presumably small-scale commercial character of the street has been lost and it now bears little relation to the quiet residential area behind it. It is thus recommended that this area be excluded from the conservation area.

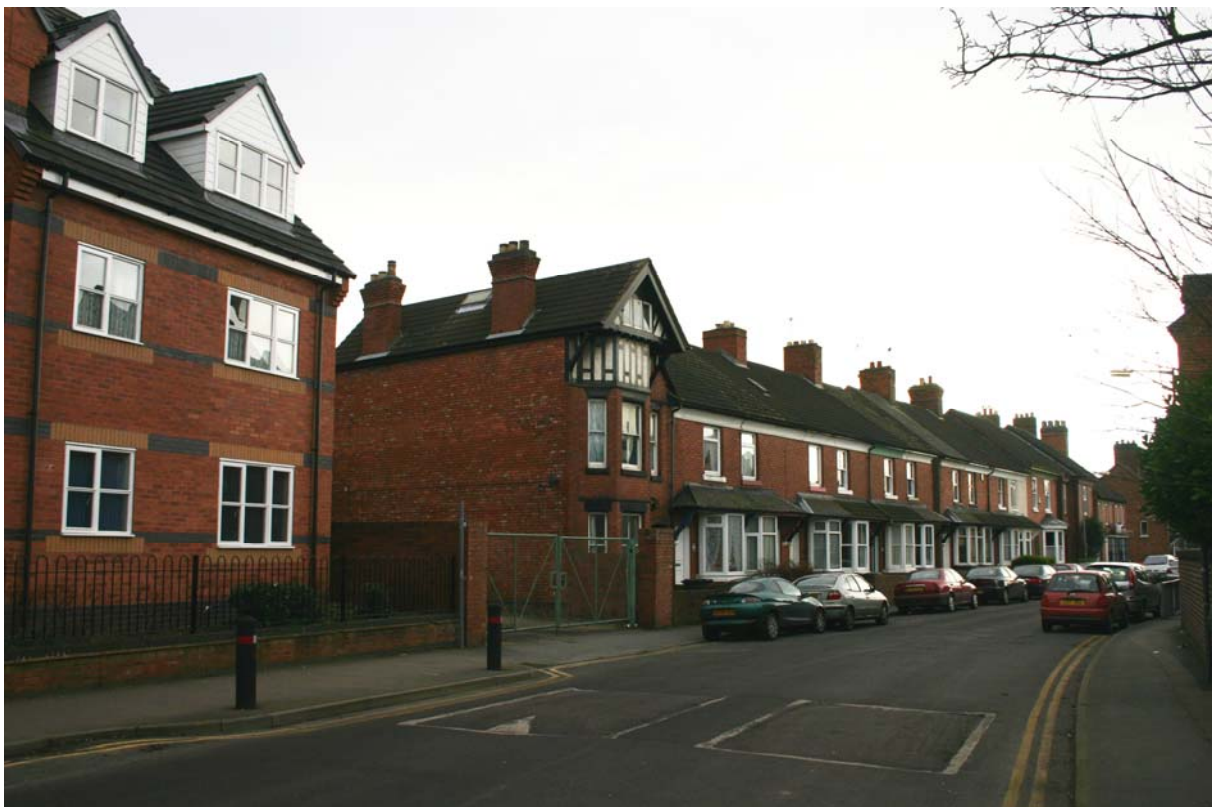
The gentle curve in Hospital Street drawing the visitor on into Barbara Street, No.29 is visually important in the street scene due to its height

- 5.1.14 On Hospital Street, No. 29 is of some visual importance – it is a tall two-storey plus attic house, with a timber-framed gable to the front. It adjoins the terrace of Nos. 23-28 and helps to make the transition in height between the terrace and the MacGregor Tithe development less abrupt.

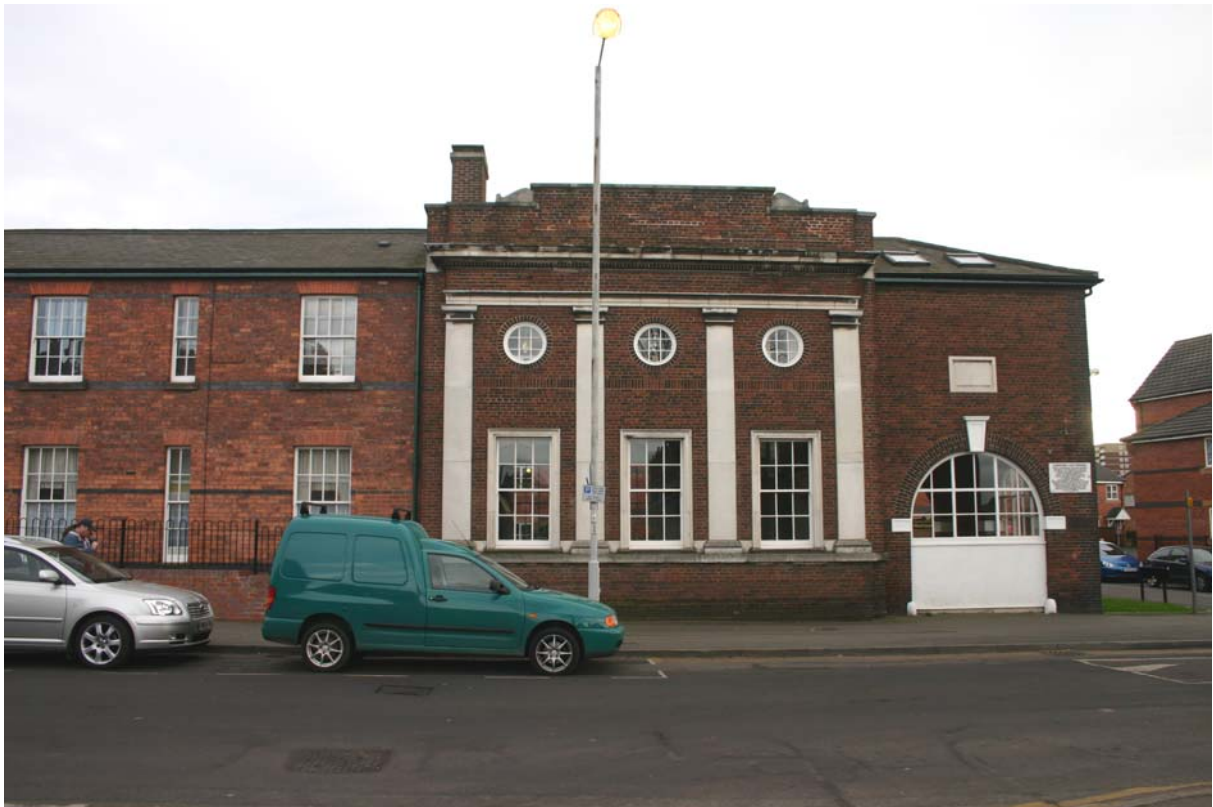
The former Cottage Hospital: the original 1880 range is to the left with the prominent 1924 neo-classical range to the right

buildings and it is recommended that it be added to the local list. Its original form was subsumed into later additions of 1889 and 1924 and what remains of the 1880 block (which originally faced west) is relatively plain, of red brick with blue brick sill band, flat brick arches and glazing bar sashes; its importance in the streetscape would have been reinforced by the long façade of the 1889 Hutton wing extension to the east along Hospital Street. This has stone lintels and sill band and heavy round-arched stone architrave to the entrance, and is enlivened by the separately-roofed tower-like bay to the corner.

5.1.8 The brown brick neoclassical addition to the west, of 1924, is of utterly different character, with its four whitewashed stone Tuscan pilasters flanking stone-dressed sashes and oculi above. The originally open arches of the arcaded bay to the right have been sympathetically enclosed and the building has been converted as part of the comprehensive redevelopment of the hospital site for housing. It provides an interesting end to views east along Barbara Street. The survival in the streetscape of this long elevation, its architectural detailing and its incorporation into the new housing scheme is to be commended and maintains a high degree of historic integrity along the street frontage. The new development itself makes visual references to the materials used in the late 19th-century hospital buildings, and is for the most part concealed behind the street frontage.

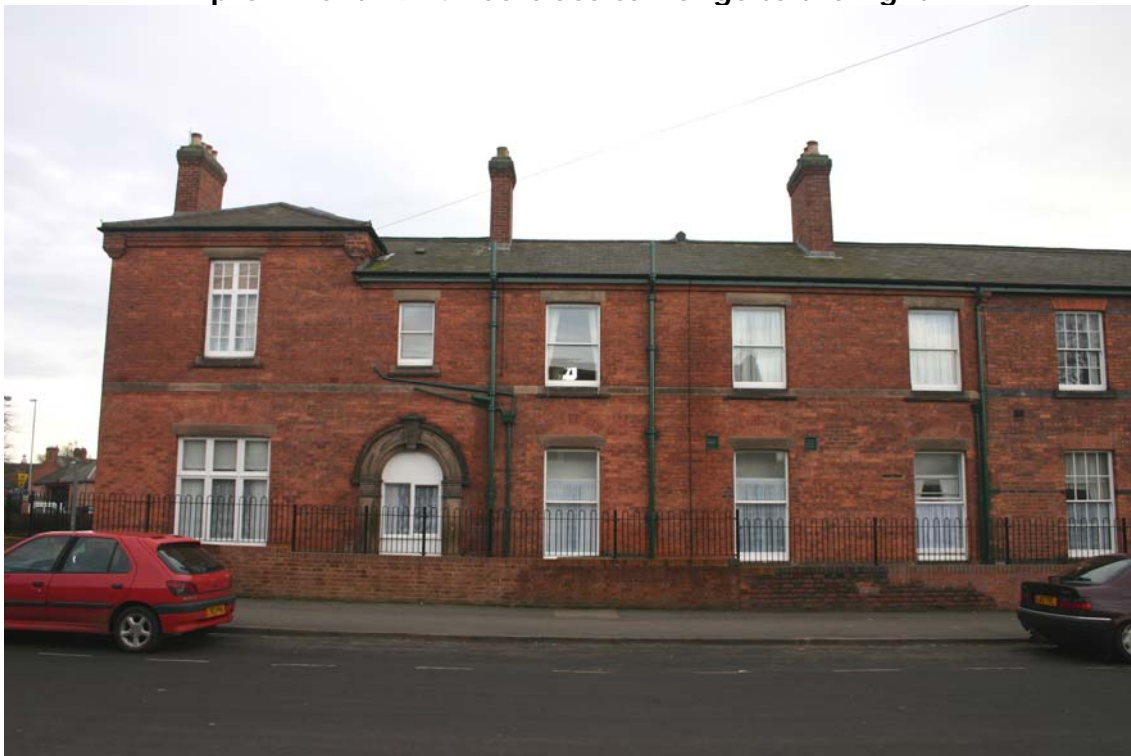
The 1889 Hutton Wing of the former Cottage Hospital. The whole hospital is recommended for local listing

- The former Cottage Hospital
- The school office and headmaster's house to Moorgate Primary School on Barbara Street/Hospital Street

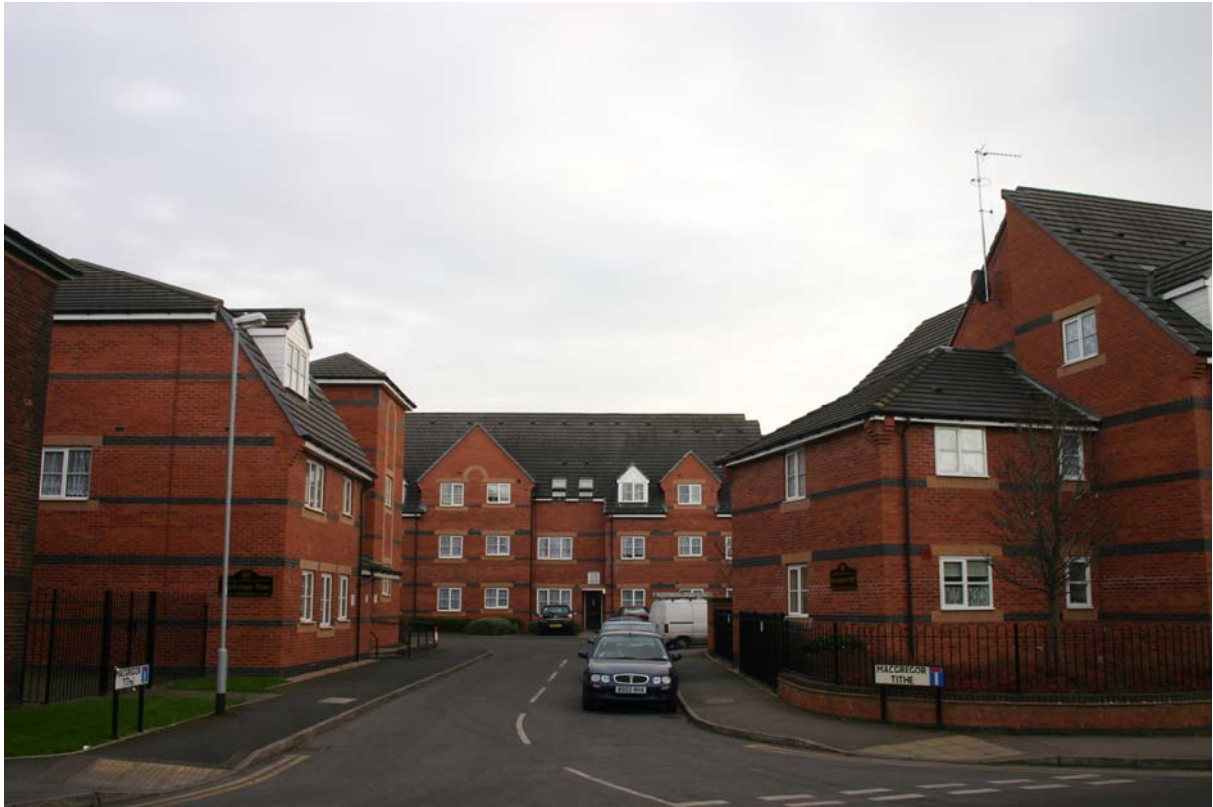
The MacGregor Tithe development, a relatively successful addition to the streetscape, which adjoins the former hospital

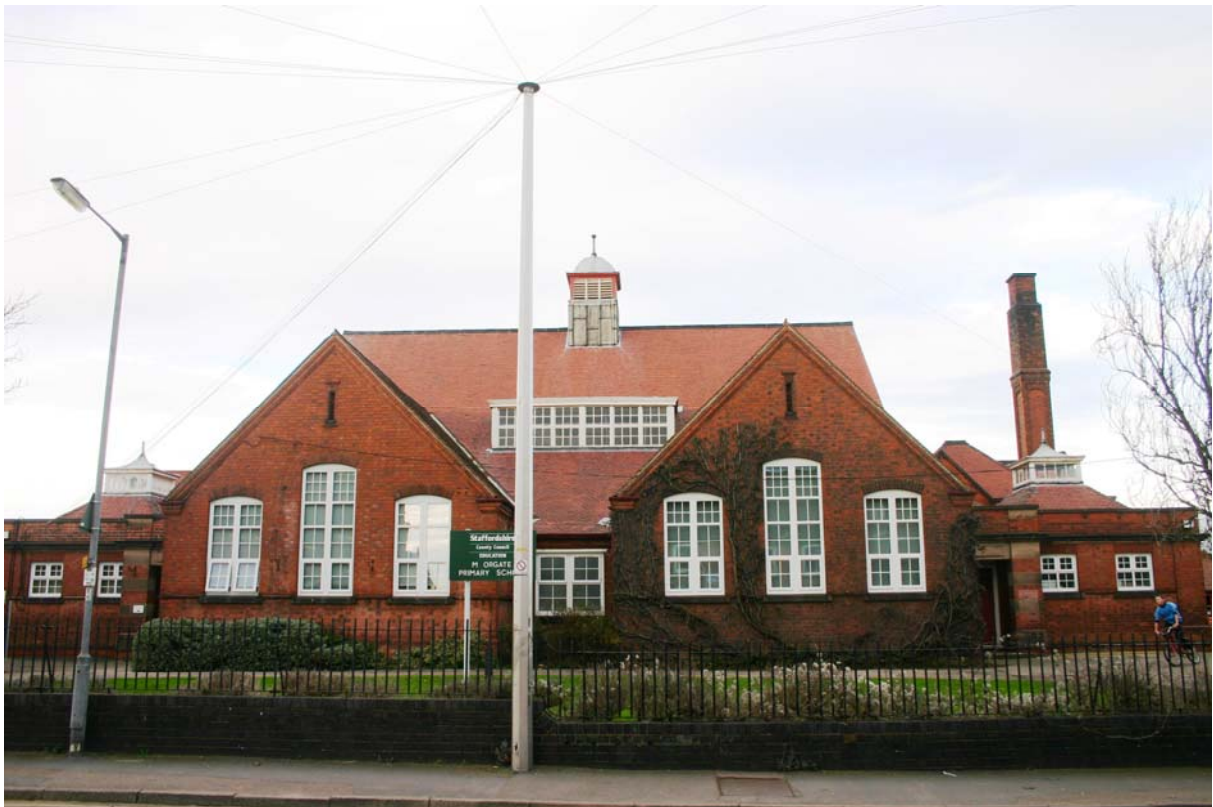
The attractive Moorgate primary school buildings on Hospital Street

5.1.9 Apart from the former hospital, it is the locally listed late 19th-century Moorgate Primary School that dominates the skyline and helps to establish the residential character of the area. This large building, with its symmetrical façade incorporating two projecting gabled wings and steeply pitched red-tile roof with domed lead dovecote, is of red brick with some stone dressings and has tall cambered-arched windows in its gabled bays. It sits well on its site, set back from the street frontage behind a lawn and railings on a dwarf wall. Views too are afforded of its east side from Hospital Street, where it is seen as an interesting jumble of red brick gables, chimneys and steep roofs.

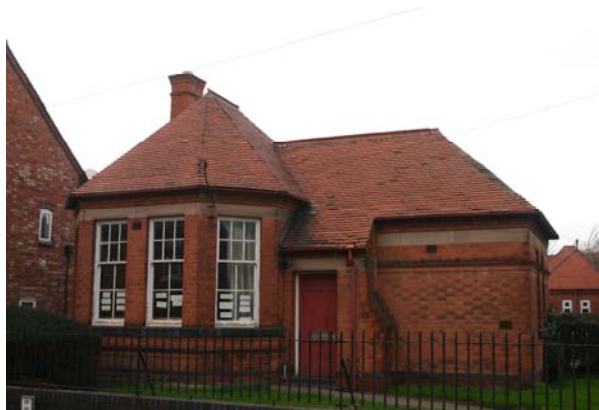
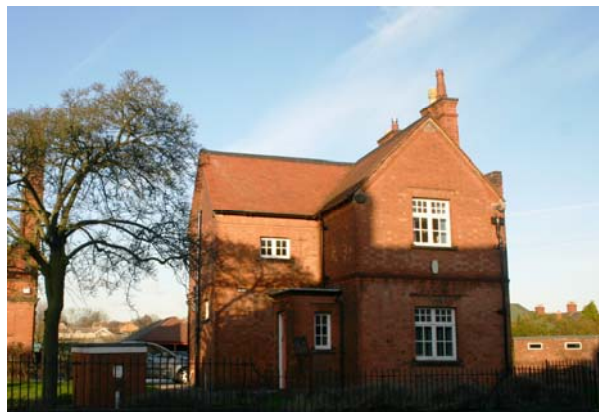
The school office and headmaster's house flanking the primary school are both recommended for local listing

5.1.10 The school is flanked by the school office and headmaster's house, both contemporary with the school, and which stand closer to the street frontage. The headmaster's house is an appealing and rather tall two-storey building with gabled wing to the street and original multi-paned casement windows. The office is single-storey with a

hexagonal bay; both buildings have red-tile roofs like the school, are characterful and of good quality. These add interest and architectural completeness to the school group and reinforce the importance of the school within the area and streetscene. Both buildings should be considered for inclusion on the local list.

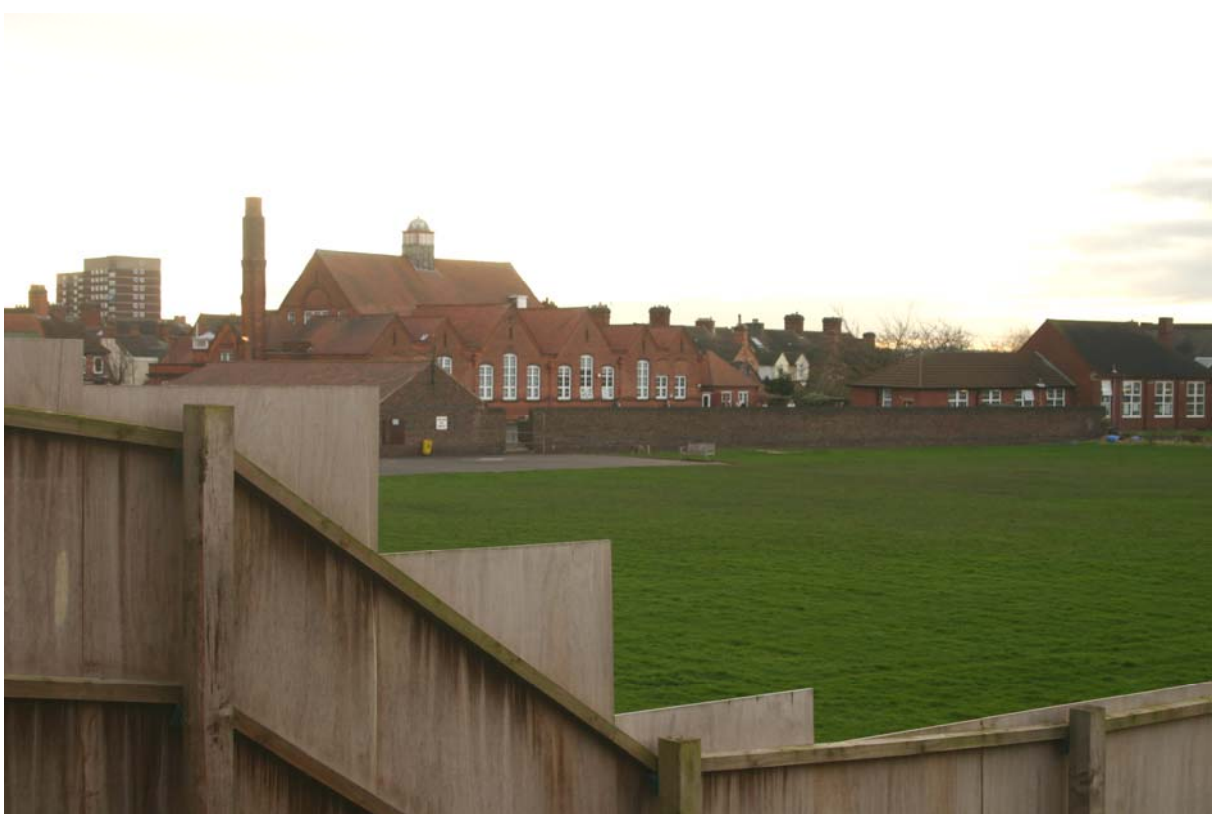
The playing fields are an important open space behind the school

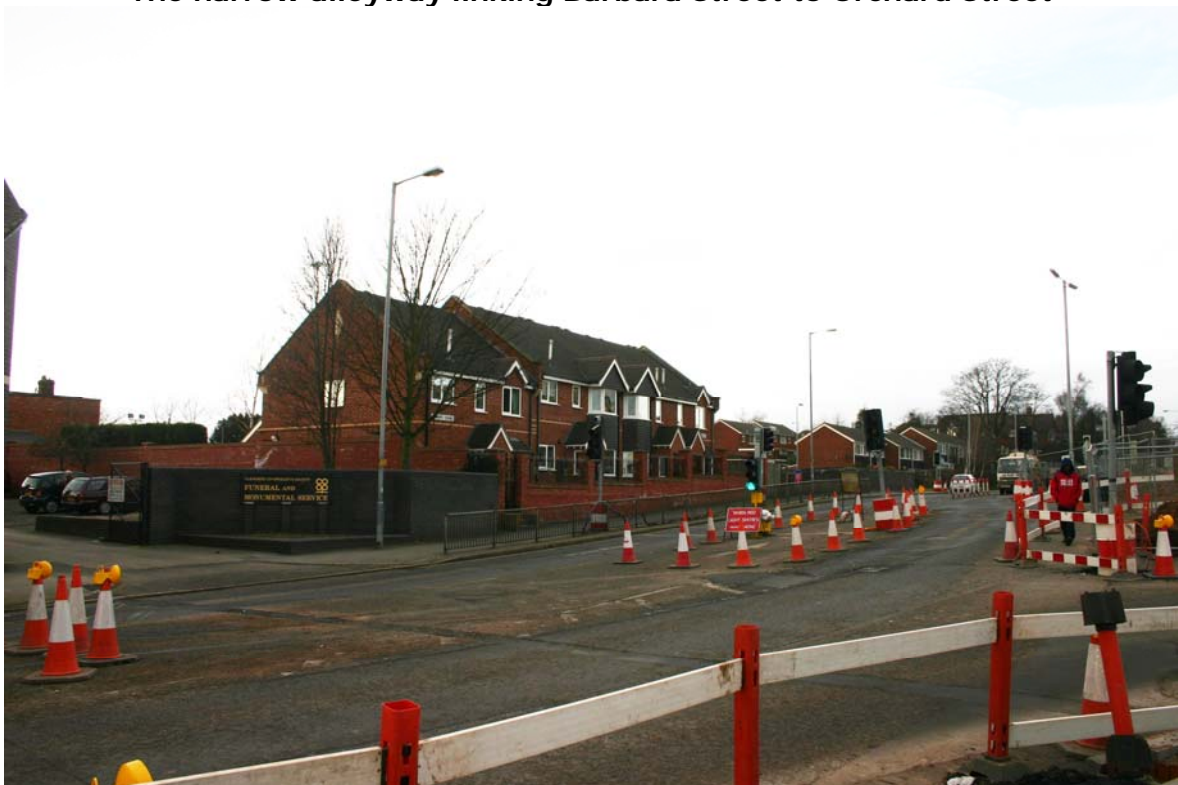
Upper Gungate has a different character with wide roads dominated by vehicles

- 5.1.6 Upper Gungate is of altogether different character, completely dominated by vehicles, the street having been widened to accommodate two major traffic intersections with Offa Drive (the ring road) and at the junction with Albert Road and Lower Gungate. Street widening has meant demolition on both sides of Upper Gungate and only an isolated group of Victorian buildings remains on the west side, these much altered. On the east side there is no longer a built-up street frontage; instead the land is occupied by a modern garage and petrol station.

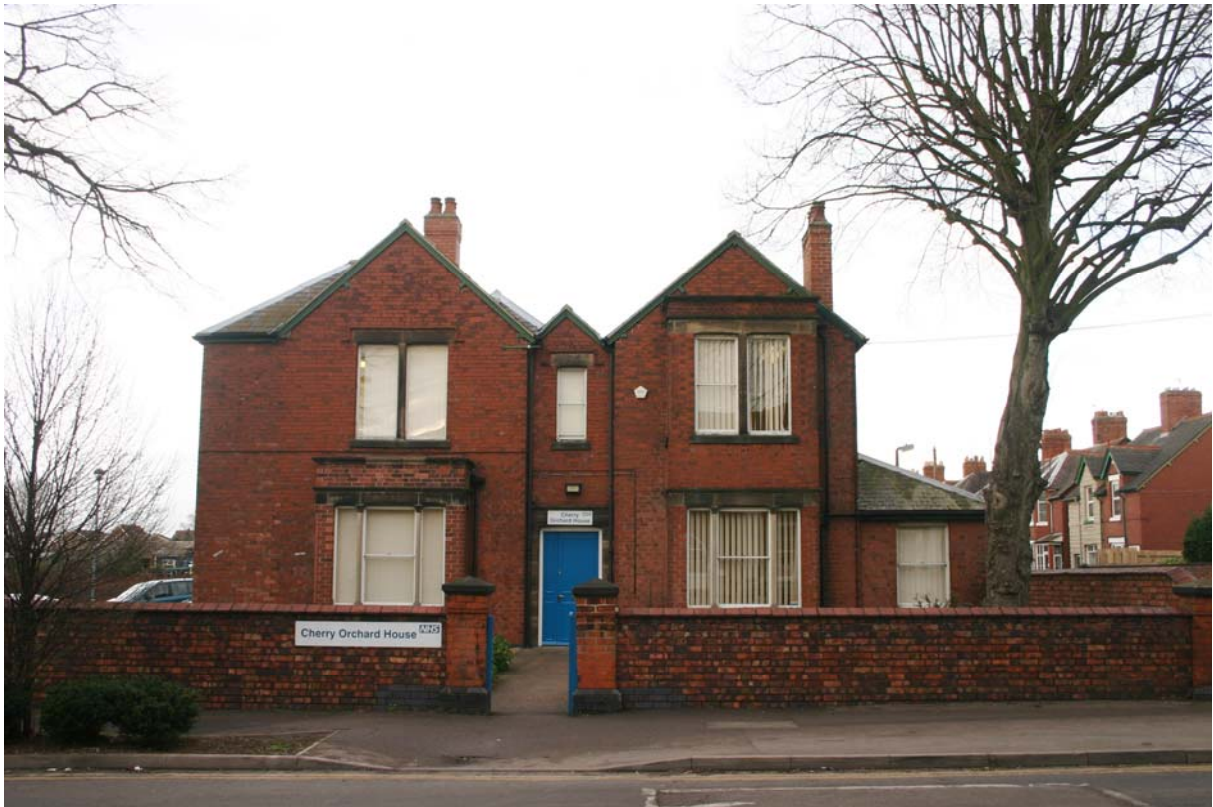
The locally listed Cherry Orchard House has been altered but still makes a contribution to the conservation area

- 5.1.11 The former vicarage (Cherry Orchard House) on the corner of Hospital Street and Cherry Street is already on the local list. This two-storey double-gabled house has seen various additions and alterations through its conversion to use by the NHS, which have not enhanced its appearance, but nevertheless it occupies a prominent corner position and still contributes to the character of the conservation area. Its original garden walls appear to have been rebuilt although original gate piers remain and the wall remains important as a visual indicator of the character of this former vicarage and garden. Adjoining it is a later 20th-century vicarage.

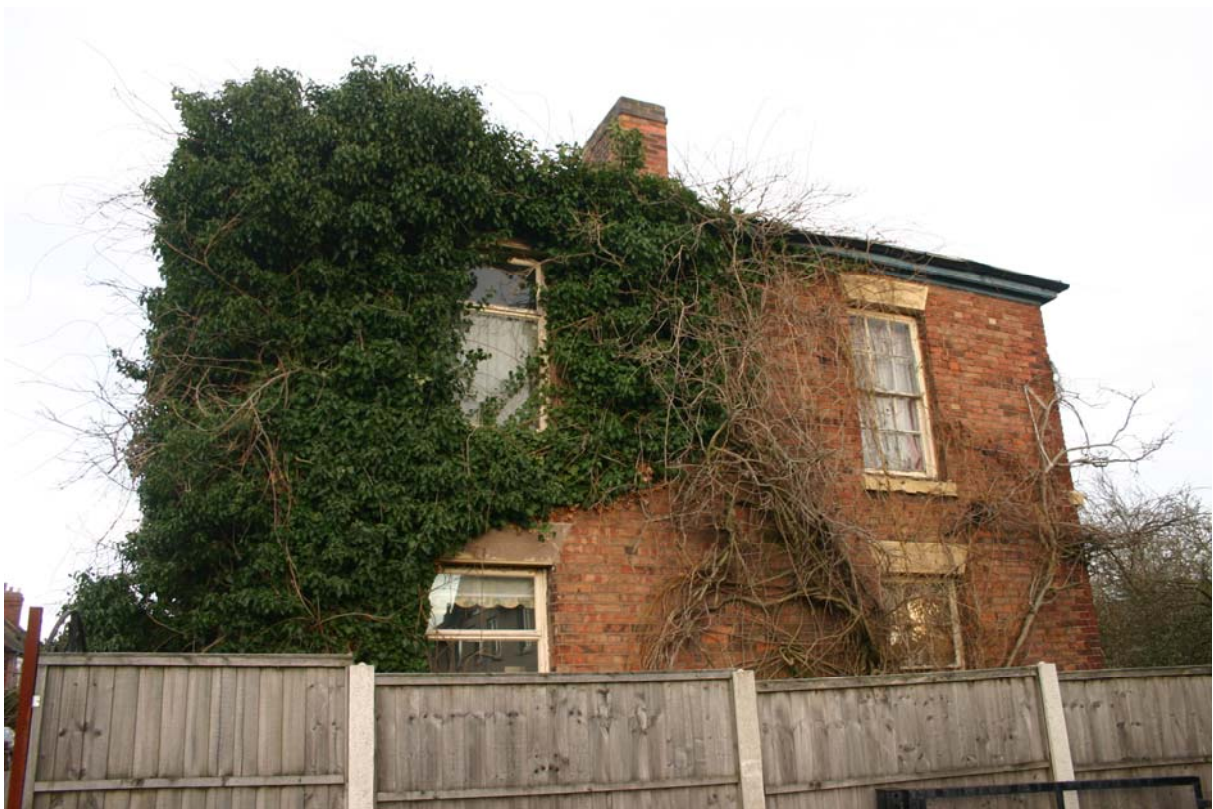
- 5.1.12 Leys House, also on the local list, a mid 19th-century residence and one of the earliest buildings surviving in the area, is located at the western end of Barbara Street and is a two-storey square-plan detached villa with stone sill band and splayed lintels, with some surviving sashes – the house is covered with climbing plants and appears in relatively poor external condition.

The locally listed Leys House, in poor condition externally

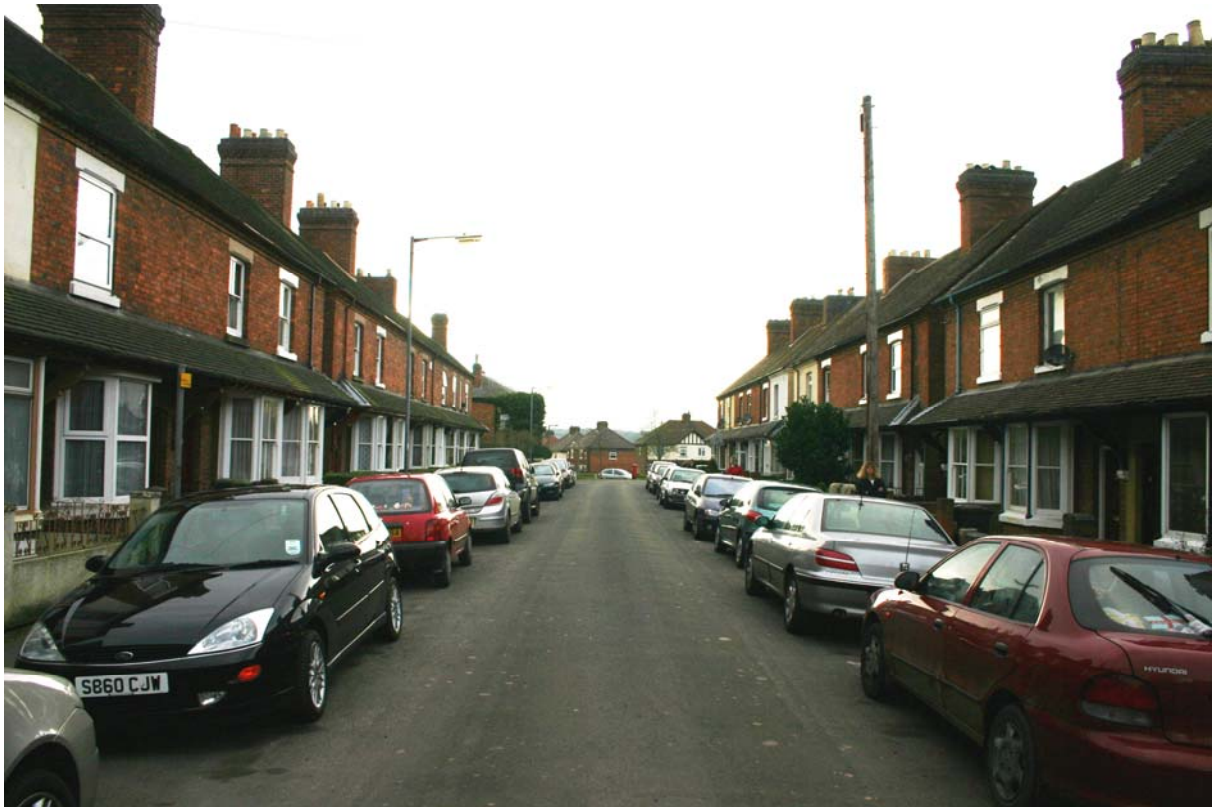
View west along Barbara Street; the continuous 'lean-to' roofs over the ground floor, the prominent chimneys, and the canted bay windows create a visually unified streetscape

- 5.1.13 The remaining buildings on the two streets are mainly terraced houses with a few semi-detached (but terrace-style) houses. On both sides of Barbara Street these are distinguished, and unified visually, by the use of a bracketed, clay tiled 'lean-to' roof over the porch and canted bay window, continuous along each separate 'block' of (normally) four houses. The heavy brick chimneys on the ridgeline are also a distinctive characteristic of the street.

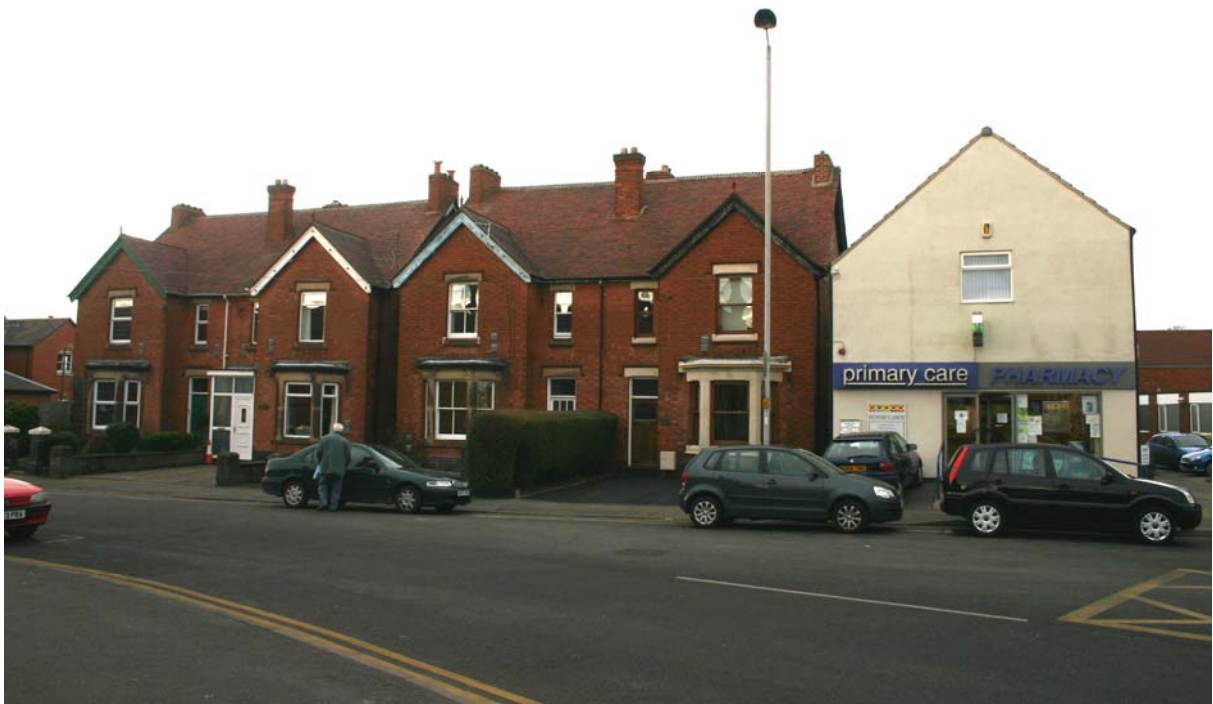
Hospital Street are Nos. 31-34, two pairs of late Victorian houses with steeply pitched red tile roofs, gabled bays with plain bargeboards to the street and stone-dressed canted bay windows. No. 30 adjoining is of the same date but has been heavily altered and is in use as a pharmacy.

Nos. 30-34 at the eastern end of Hospital Street

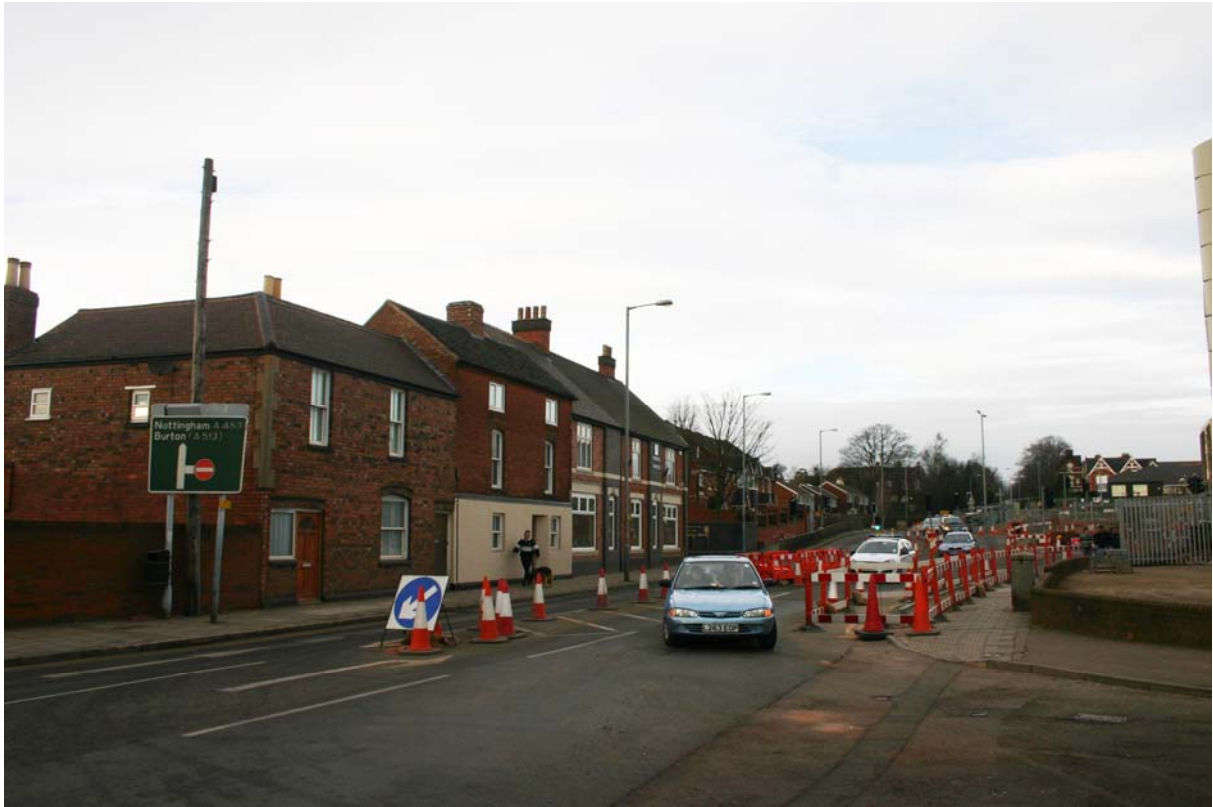
- 5.1.16 The surviving Victorian buildings on Upper Gungate are Nos. 27-37. These stand hard on the street frontage and, despite alterations, still manage to convey some small sense of what this street must have been like prior to the road widening and the demolition of most of its Victorian properties. No. 27 is of square plan, brick-built with stone quoins to the southwest corner. It has seen alteration to its fenestration, as has the adjoining Nos. 29-29A, a three-storey building, with ground floor completely reconfigured and rendered. Nos. 33-37, a row of two-storey shops, has also been altered, but relatively more successfully. North of these is a late 20th-century housing development, of no particular architectural merit.

Surviving (but altered) Victorian buildings on Upper Gungate

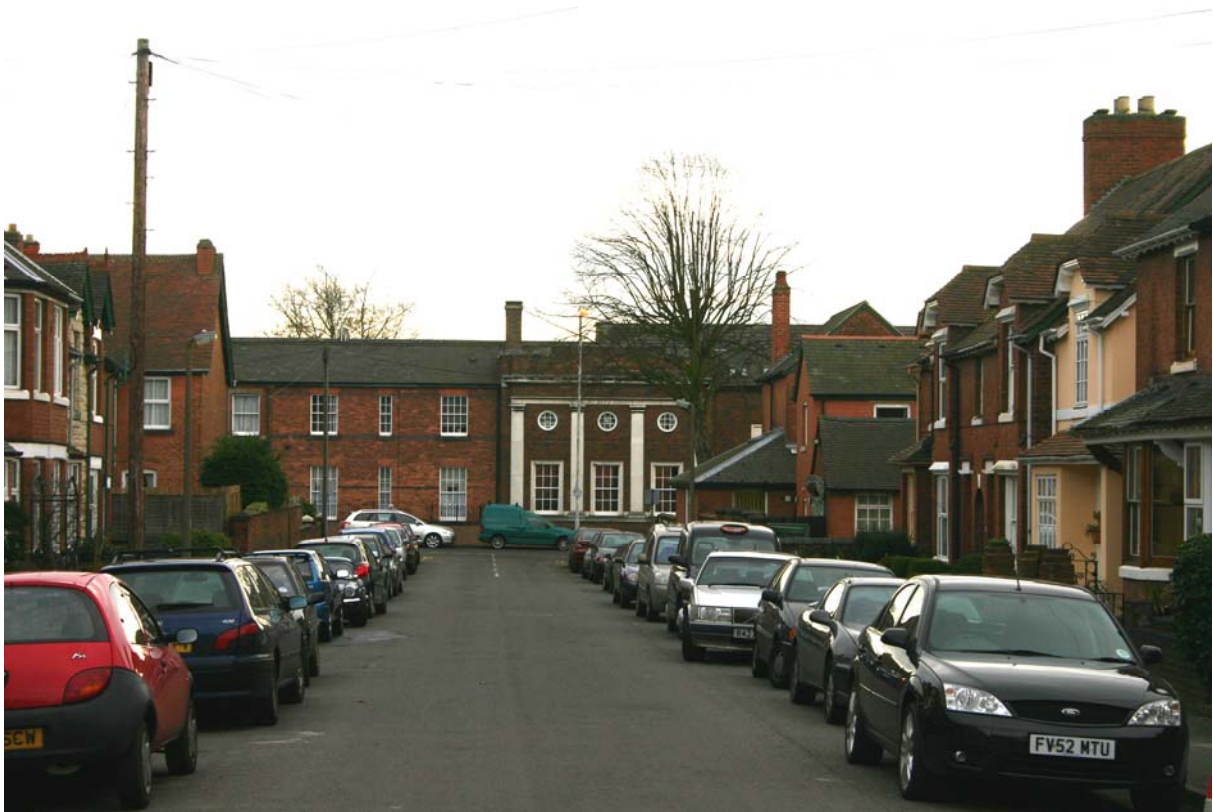
The view south down Cherry Street is terminated rather grandly by the former hospital

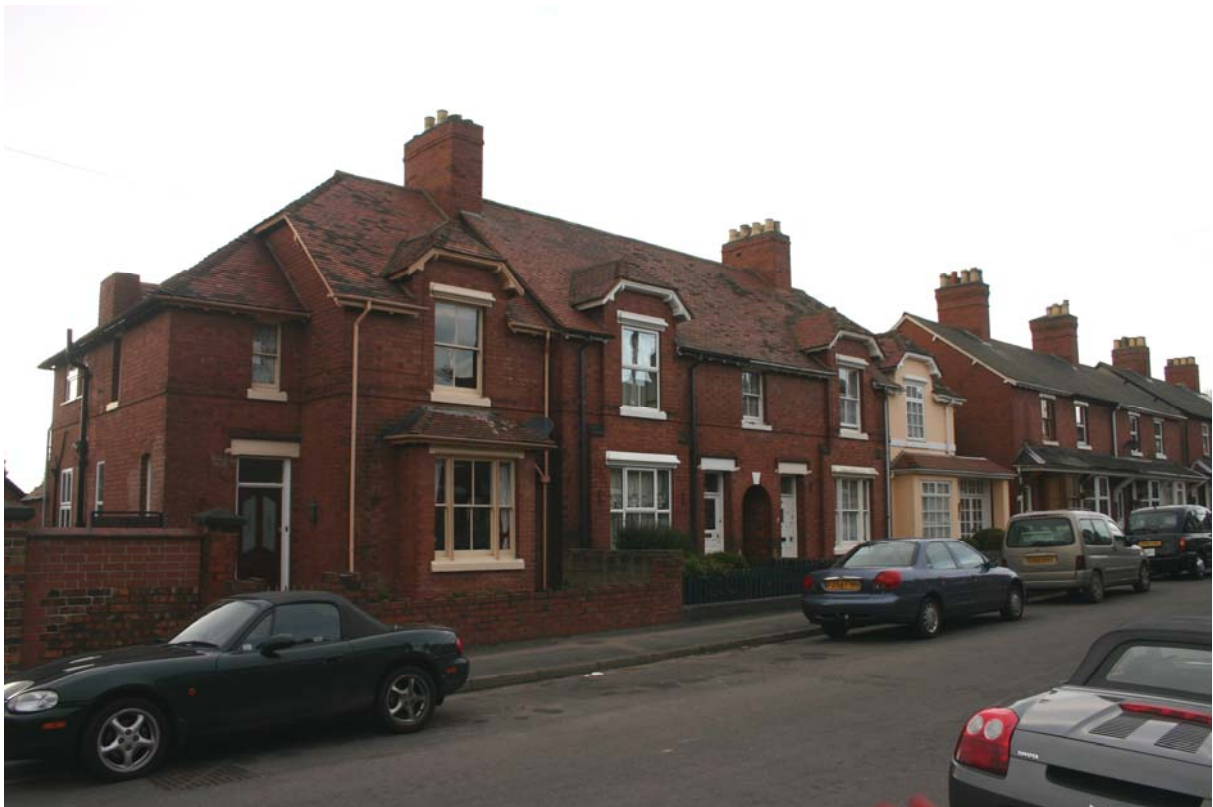
The more unusual design of Nos. 1-4 Cherry Street

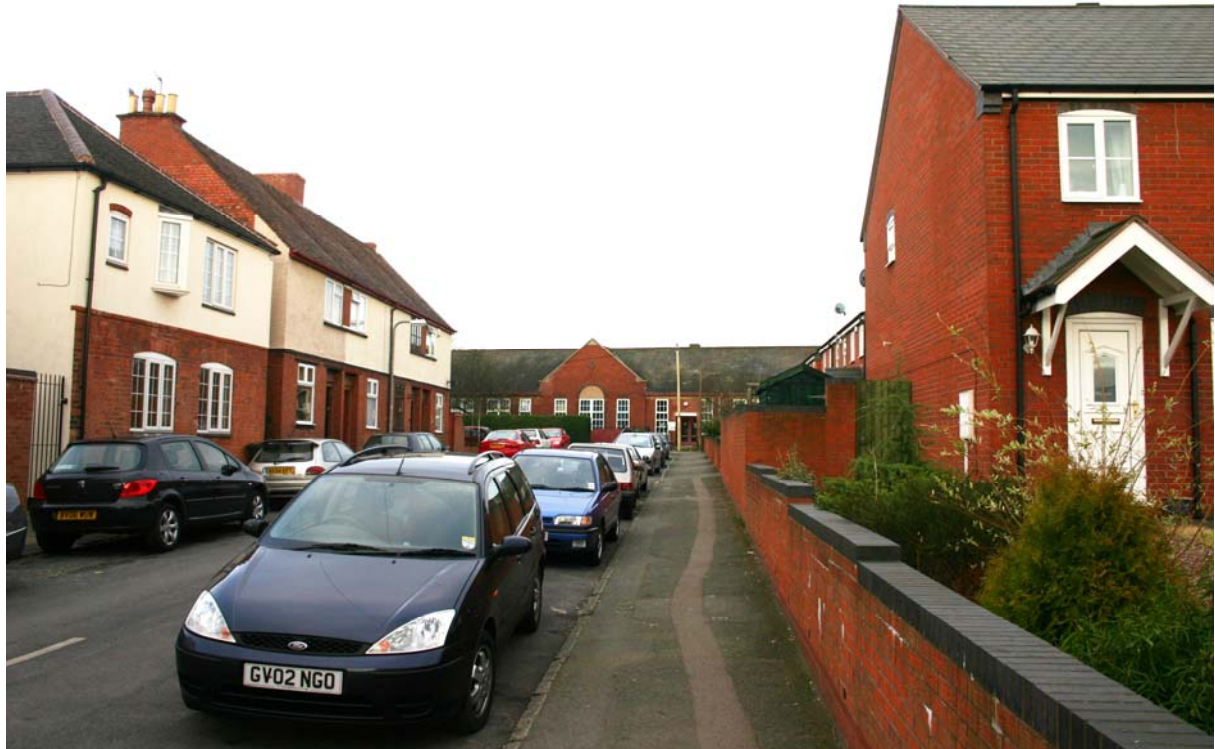
Planned view east along Moorgate towards the school building; the historic character of the view has been diluted by the demolition of a further school building and its replacement with modern housing developments (on the right)

- 5.3.3 The historic character of the east-west section of Moorgate has been diluted by the demolition of a third late 1920s school building formerly fronting its south side, and its replacement with unappealing and rather box-like early 21st-century housing; the early 20th-century houses opposite have also seen significant alterations to fenestration and the school building itself has had replacement windows and railings.

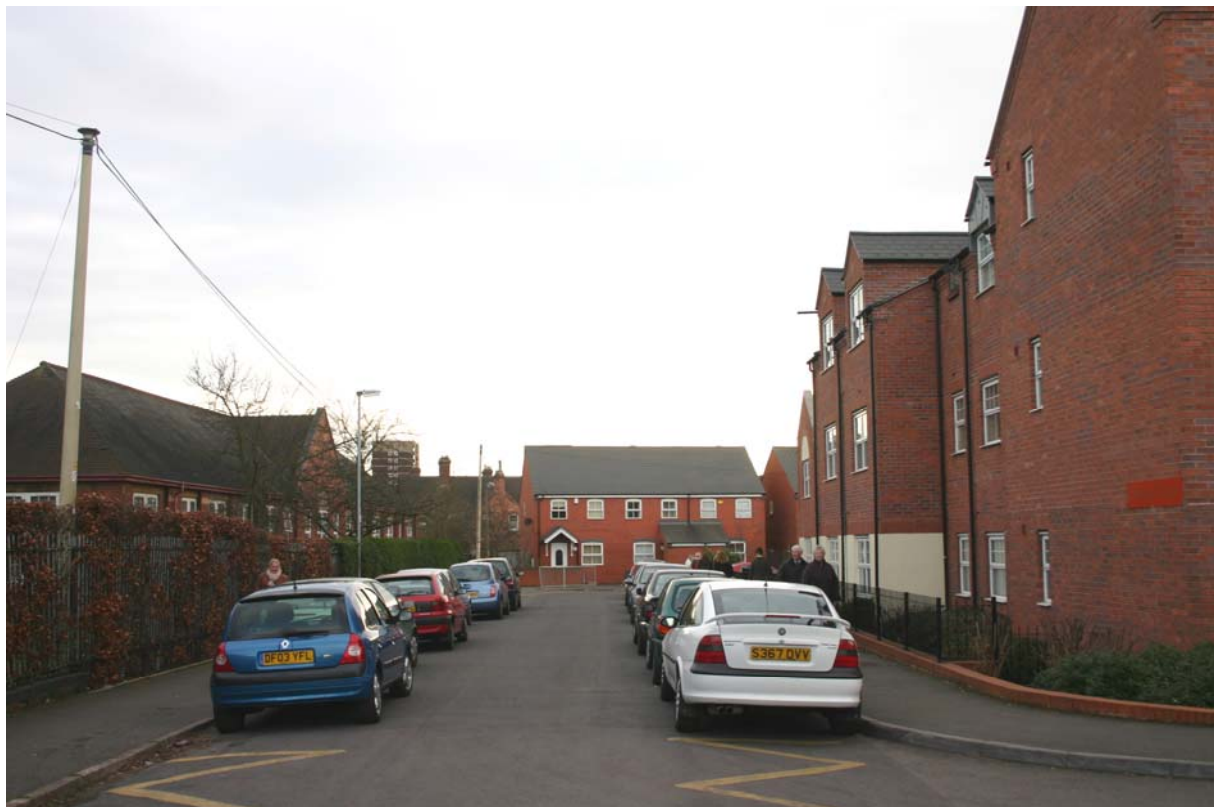
The impact of modern housing developments on Moorgate (looking south)

- 5.3.4 Views along the north-south section of the street fare little better, the street now dominated by the large-scale three-storey flats development of Oakland Court, which dwarfs the single-storey school building opposite, and the view south terminated by the modern housing referred to above. In the distance one of the tower-blocks on Lichfield Street can be seen.

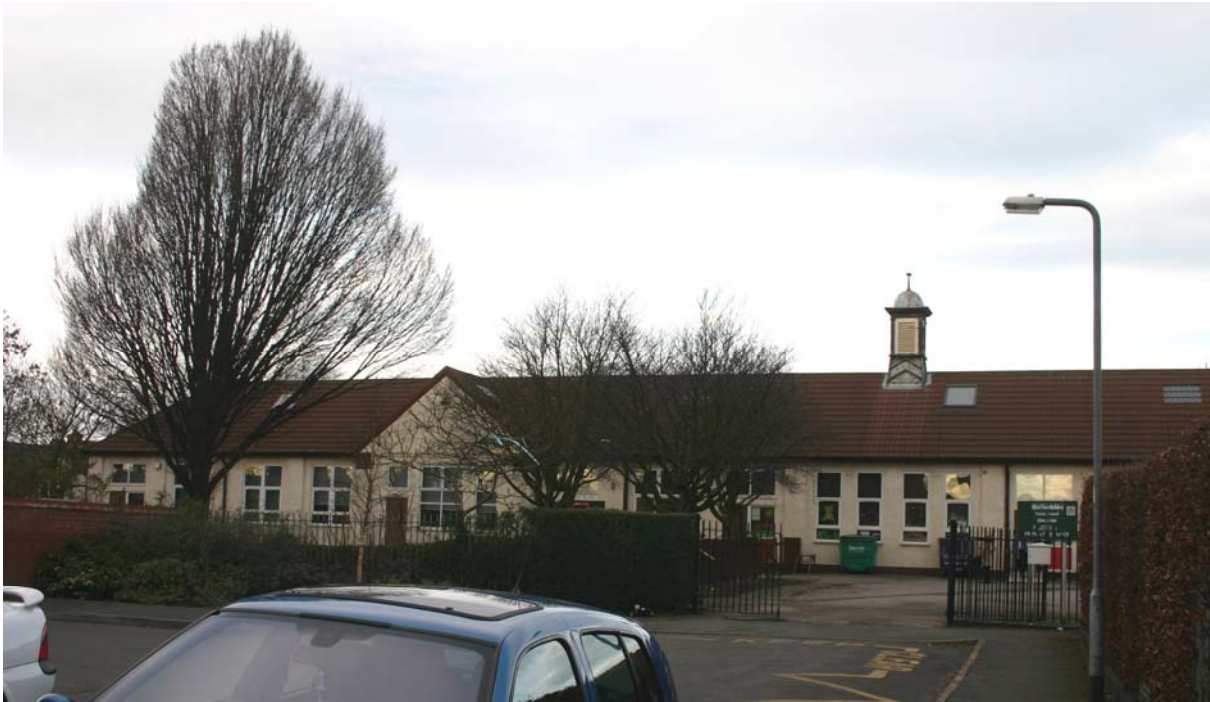
- 5.3.7 The northern building is of less architectural merit and has unfortunately been rendered making it appear out of place with the rest of the conservation area. The roof has been re-tiled with pantiles and all the building's windows have been replaced with uPVC, giving it a rather bland appearance, alleviated only by the rather charming domed lead dovecote on the roof, which provides a visual link to the original 19th-century school building.

Primary school building (much altered) at the northern end of Moorgate
