**CONSERVATION AREA
CHARACTER APPRAISAL**

**HOSPITAL STREET,
TAMWORTH**

**TAMWORTH BOROUGH
COUNCIL**

Date: June 2007

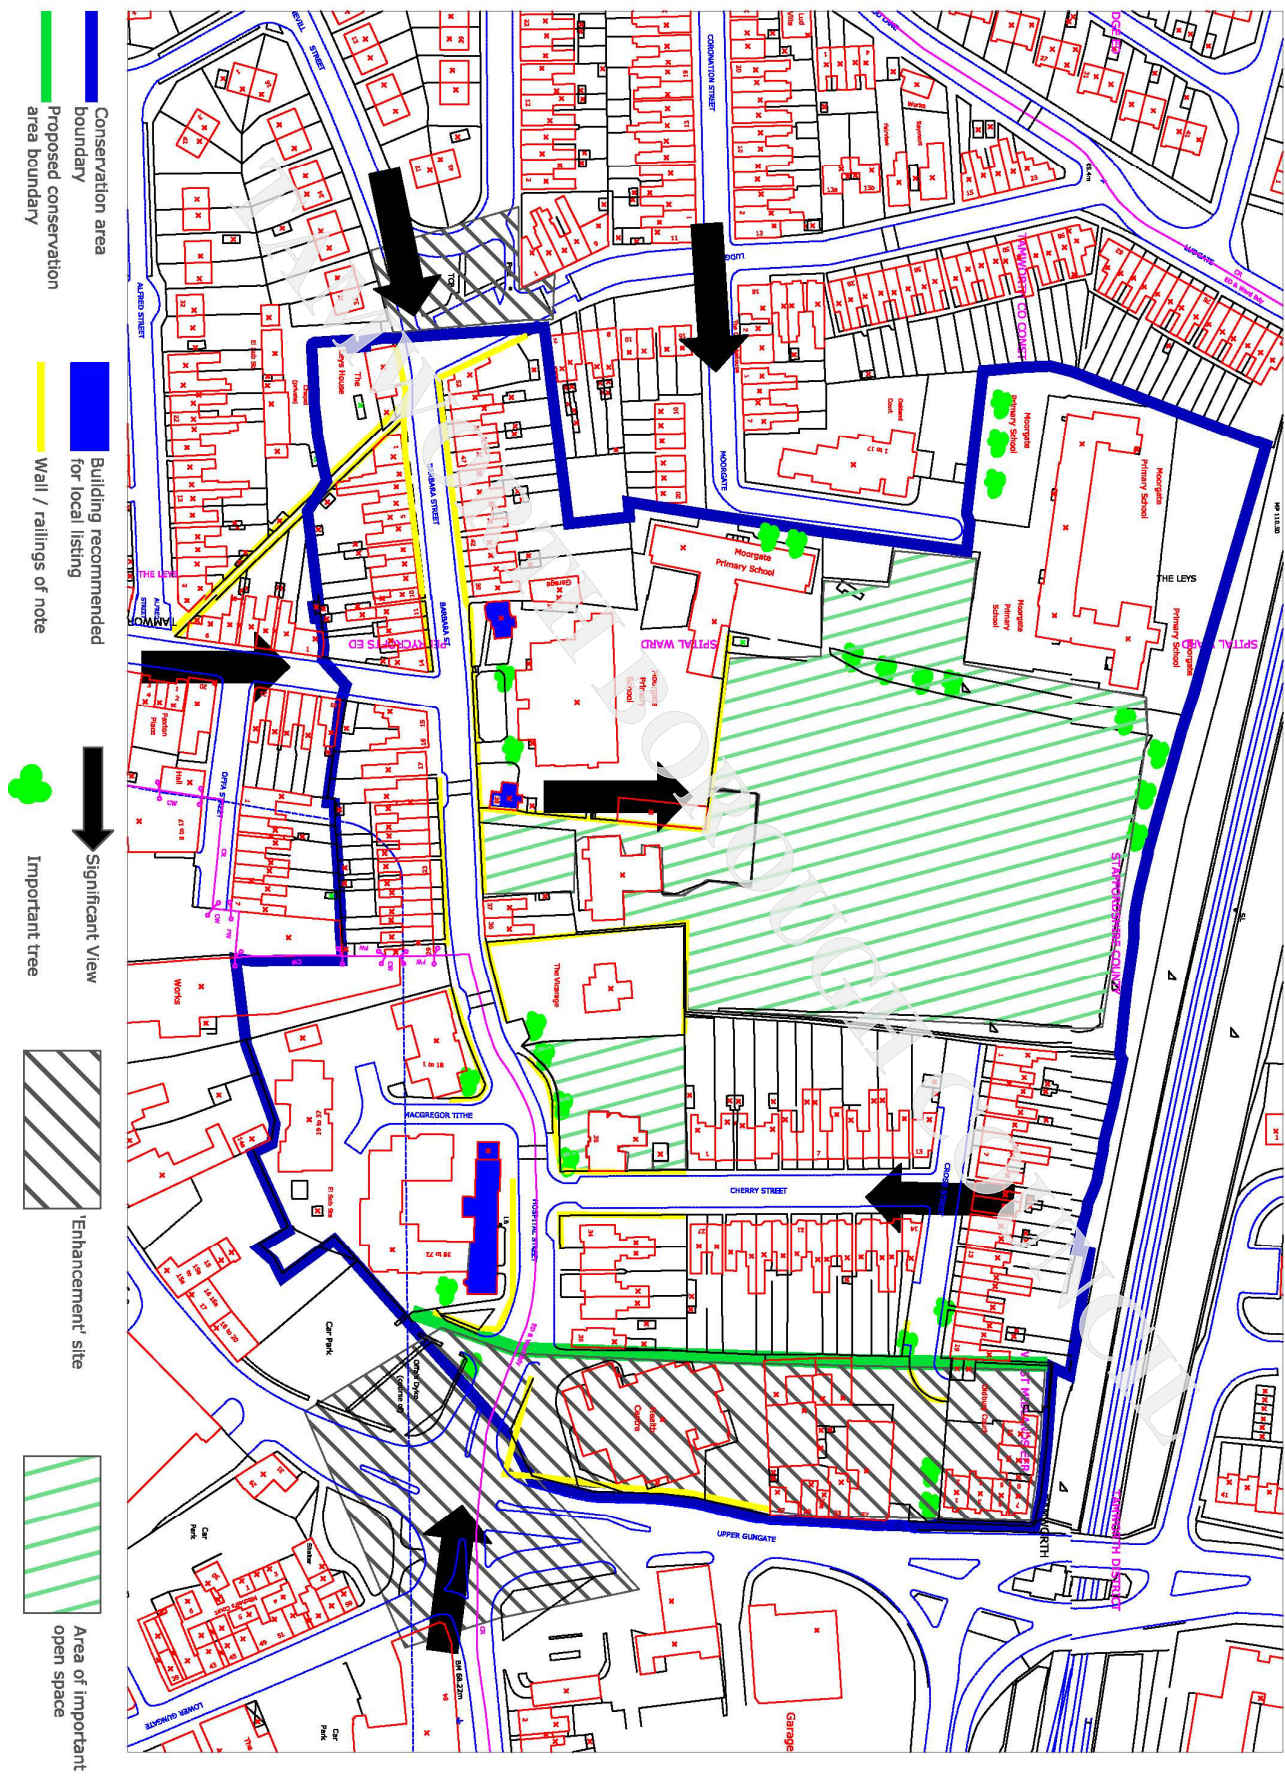
Plan 2 Hospital Street Conservation Area; Proposals and Recommendations

- 2.1 The set of plans in Appendix 2 aim to identify the elements which contribute to the character and appearance of the conservation area, and also illustrate recommendations for alterations to the conservation area boundary and for additional designations.

6.1 It is proposed that the conservation area boundary is amended along the eastern side to exclude the Health Centre and other properties along Upper Gungate. This is proposed primarily because the historic character of the street has been heavily degraded by the widening of Upper Gungate, the major traffic intersections, and the redevelopment of its frontages with buildings that neither enhance nor preserve the character and appearance of the conservation area. The surviving Victorian buildings have also been compromised by alterations. It is proposed to redraw the boundary along the continuous property boundary that runs along the rear plots of the properties fronting the east side of Cherry Street.
